LAKE SOMERSET DAM

PHASE I INSPECTION REPORT  
NATIONAL DAM INSPECTION PROGRAM

AUGUST 1979

Lake Somerset Dam: NDI I.D. No. PA-00229

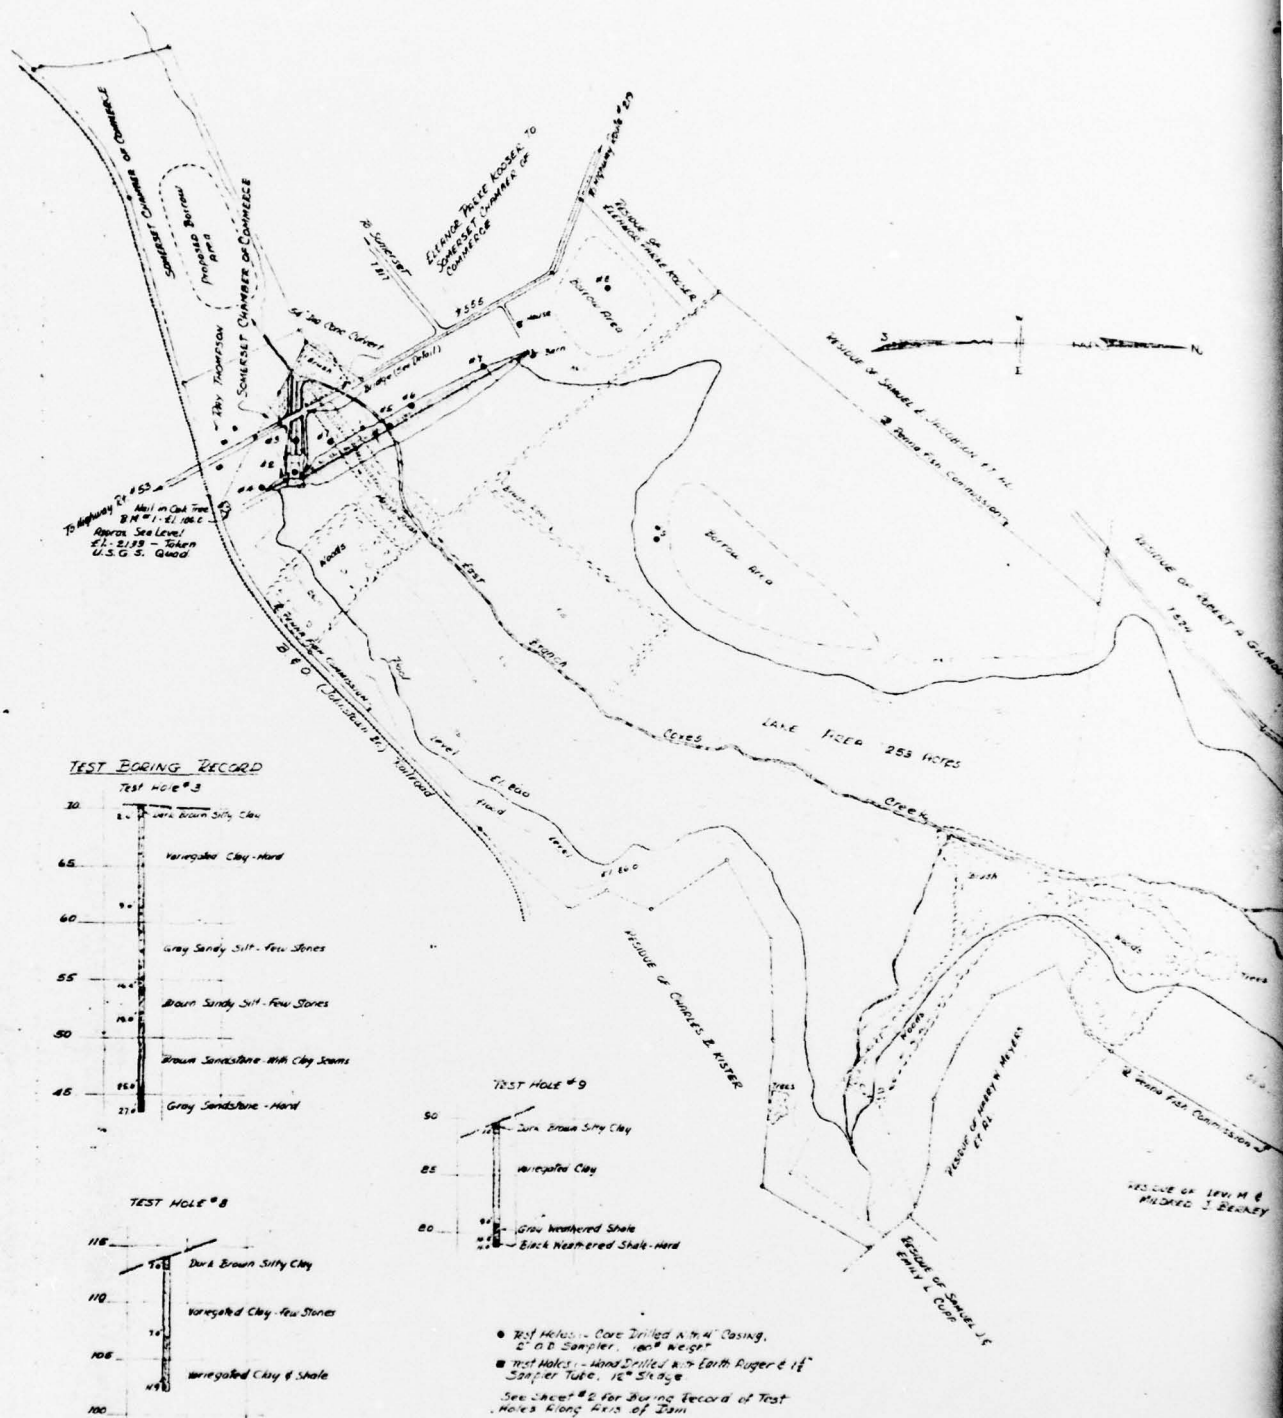
FIGURE 1 - LAKE SOMERSET DAM  
GENERAL PLAN : FIELD INSPECTION NOTES

ITEM	OBSERVATIONS AND/OR REMARKS	NDI# PA - 229
DAMP AREAS IRREGULAR VEGETATION (LUSH OR DEAD PLANTS)	Extensive areas of saturation were noted in the flat area beyond the downstream embankment toe (see Figure 1, Appendix F).	
ANY NOTICEABLE SEEPAGE	Substantial seepage was observed to be issuing through the downstream face of the embankment and through the flat area immediately downstream from the embankment toe. Wet or damp areas were found along the downstream face as high as elevations which were only 6' below the normal pool level. See Appendix F, Figure 1 for a field sketch which outlines the areas of concern.	
STAFF GAGE AND RECORDER	None.	
DRAINS	Two drains have been installed along the downstream toe to transport some of the seepage water to the outlet channel. Estimated discharge at the time of inspection was in excess of about 10 gallons per minute.

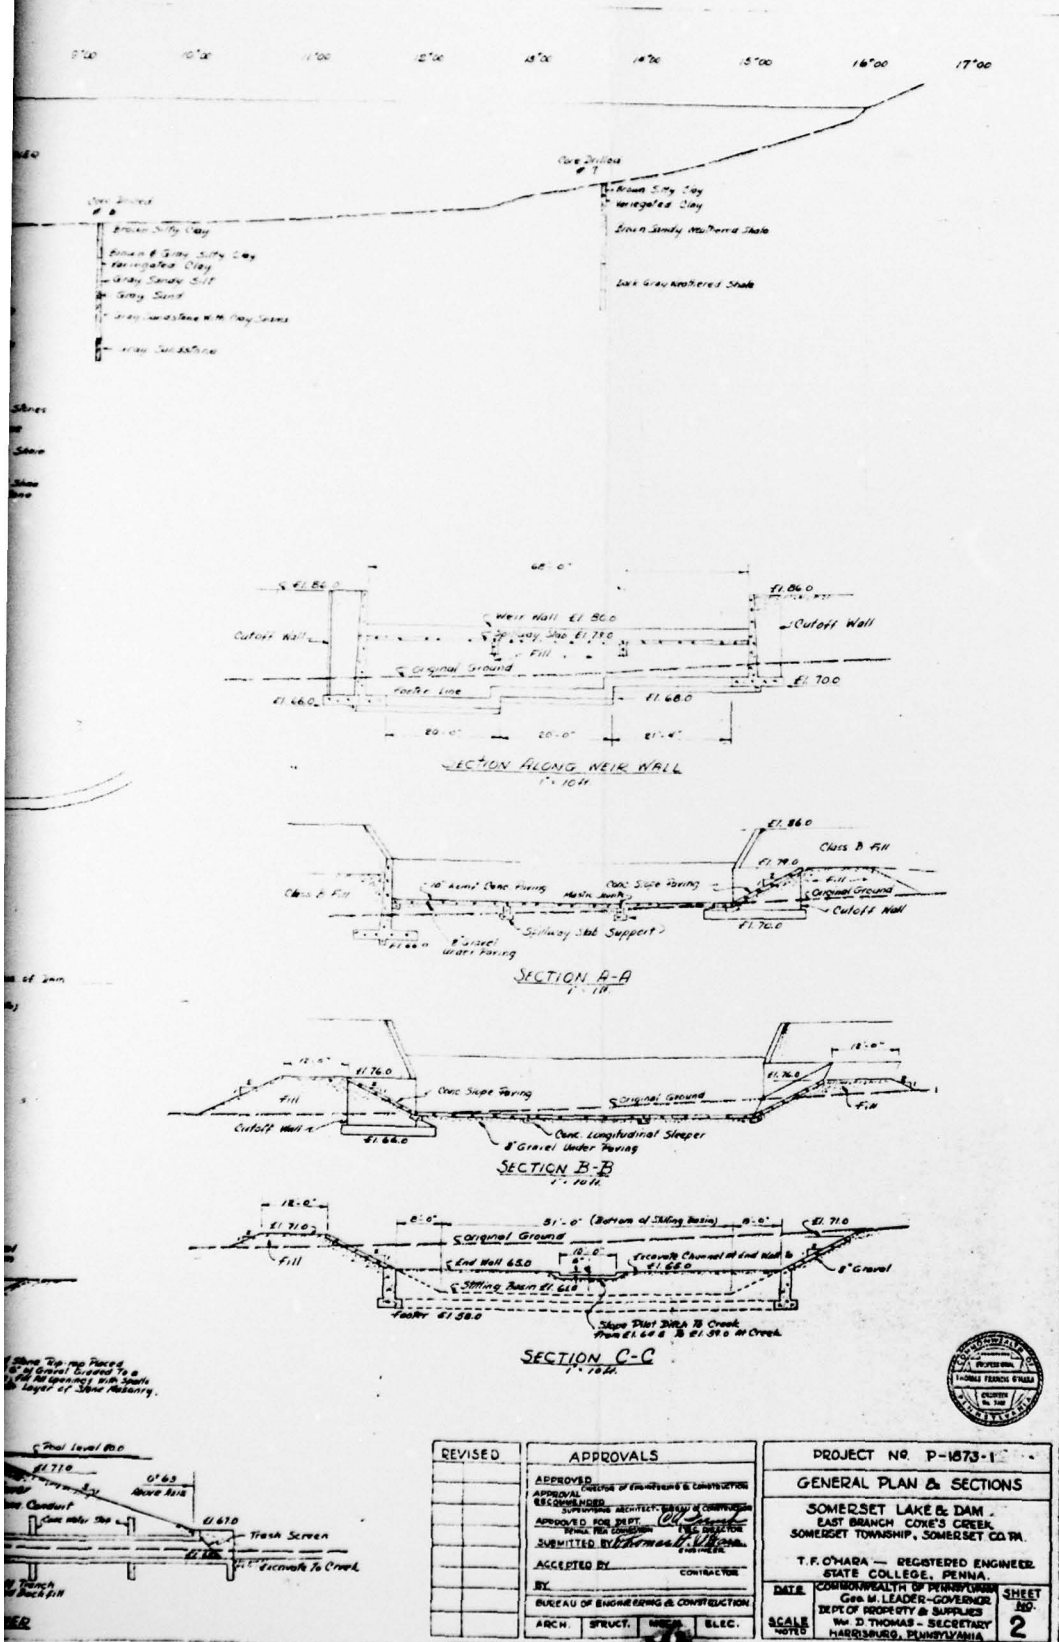
FIGURE 3

1. Embankment. Specifications and contract drawings indicate that the embankment is a zoned, rolled earth structure, 25 feet high having a length of 1550 feet. The embankment contains a shallow cut-off trench 3 feet deep and 10 feet wide at its base with 1H:1V side slopes (See Figure 3).

a) Spillway. The spillway is a reinforced concrete chute structure with an ogee-like weir located near the left abutment (see Figure 3). The crest length of the weir is 68 feet. Maximum flow depth over the weir is 6 feet and the forebay depth is 3 feet.

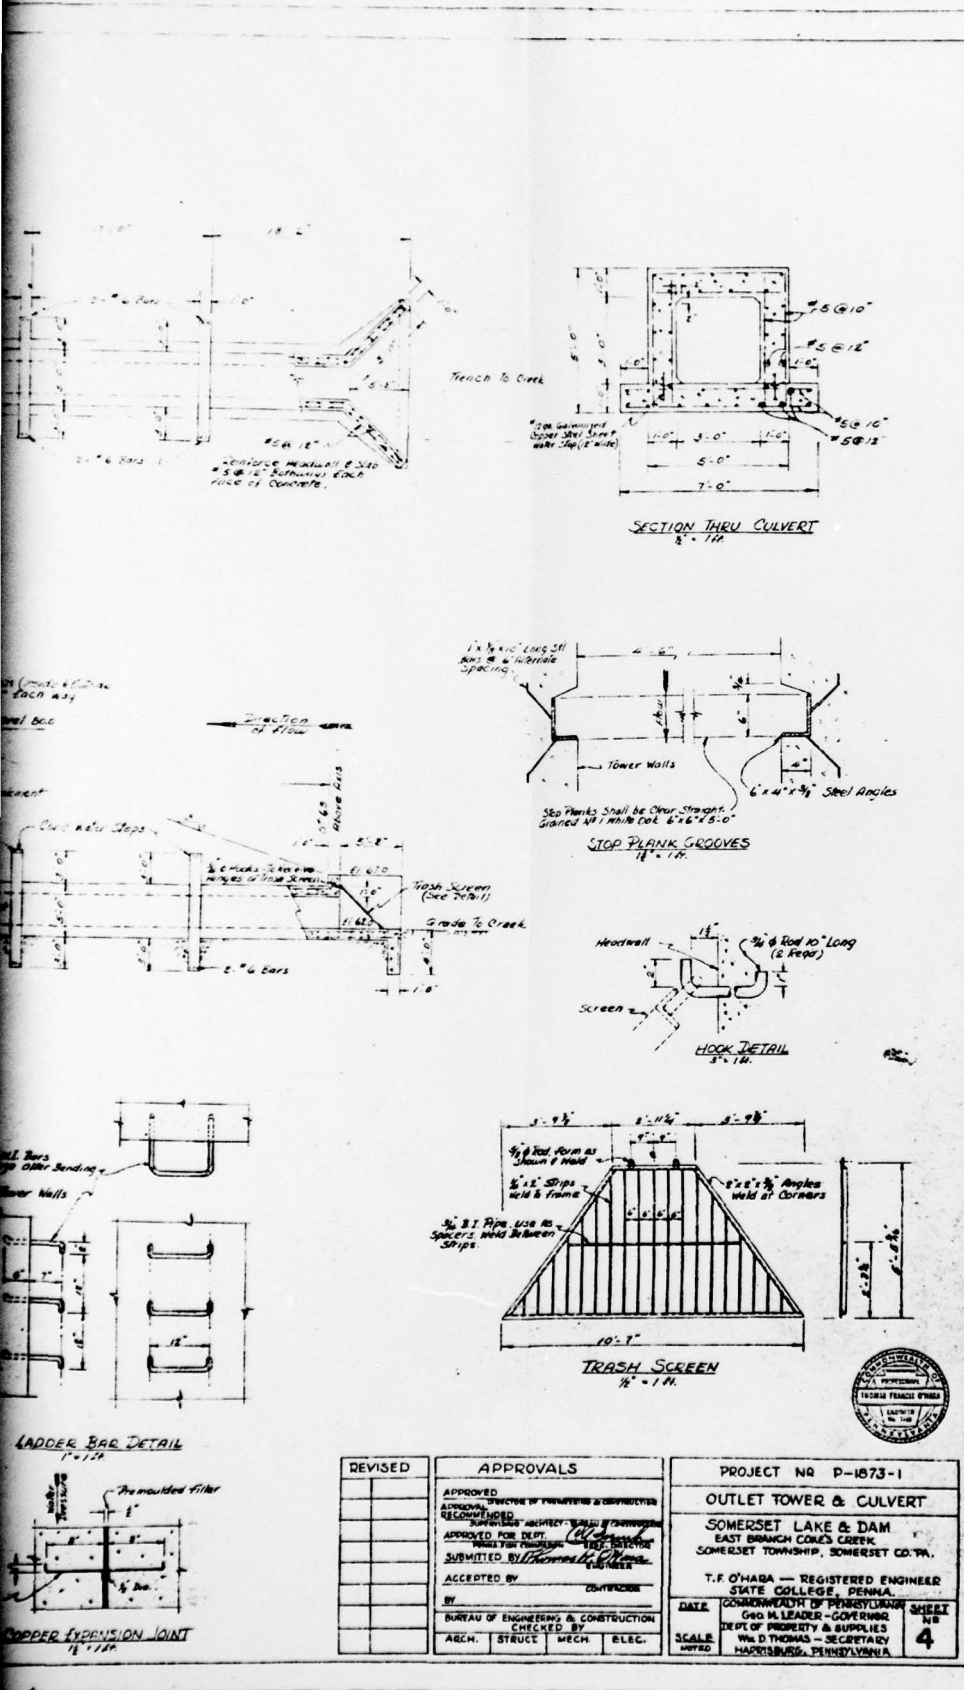
FIGURE 5

b) Outlet Works. The outlet works consists of a 3-foot square (inside dimension) concrete box culvert and a concrete control tower with flow regulated by stop logs (see Figure 5). The box culvert is supported on a 7-foot wide concrete base and is provided with four concrete anti-seep collars. The section downstream of the control tower also contains an expansion joint.

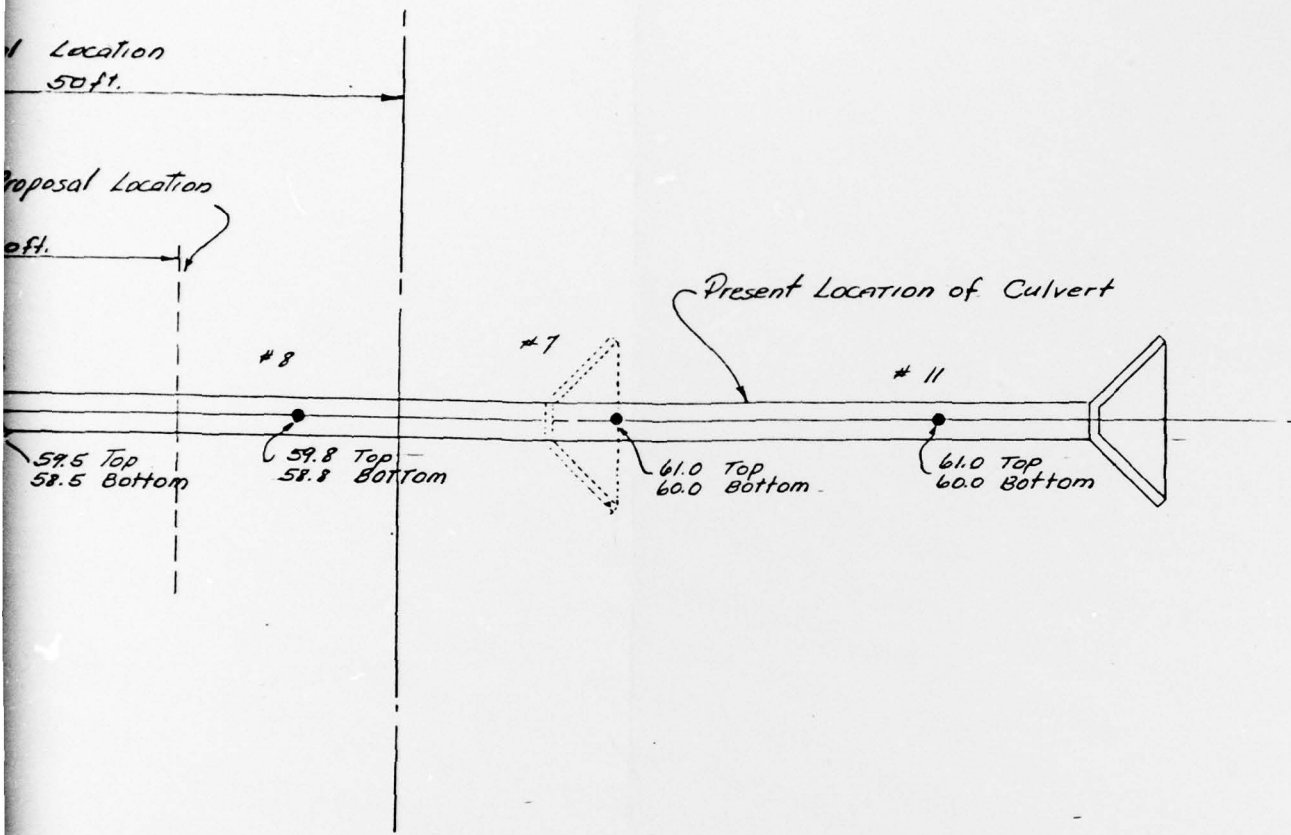
FIGURE 6

Formation. They also noted that one of the boreholes near the proposed stilling basin showed slight artesian pressure. The investigators presumed that the aquifer involved in the artesian conditions was at the bedrock level where the materials showed tan discoloration. The existence of artesian conditions was reinforced when three sand boils were discovered prior to construction near the proposed toe, and the dam was relocated some 50 feet further upstream (see Figure 6).
